Safety Alert

From the LEG HSE Department

Smashed Finger Under Air Ride Seat

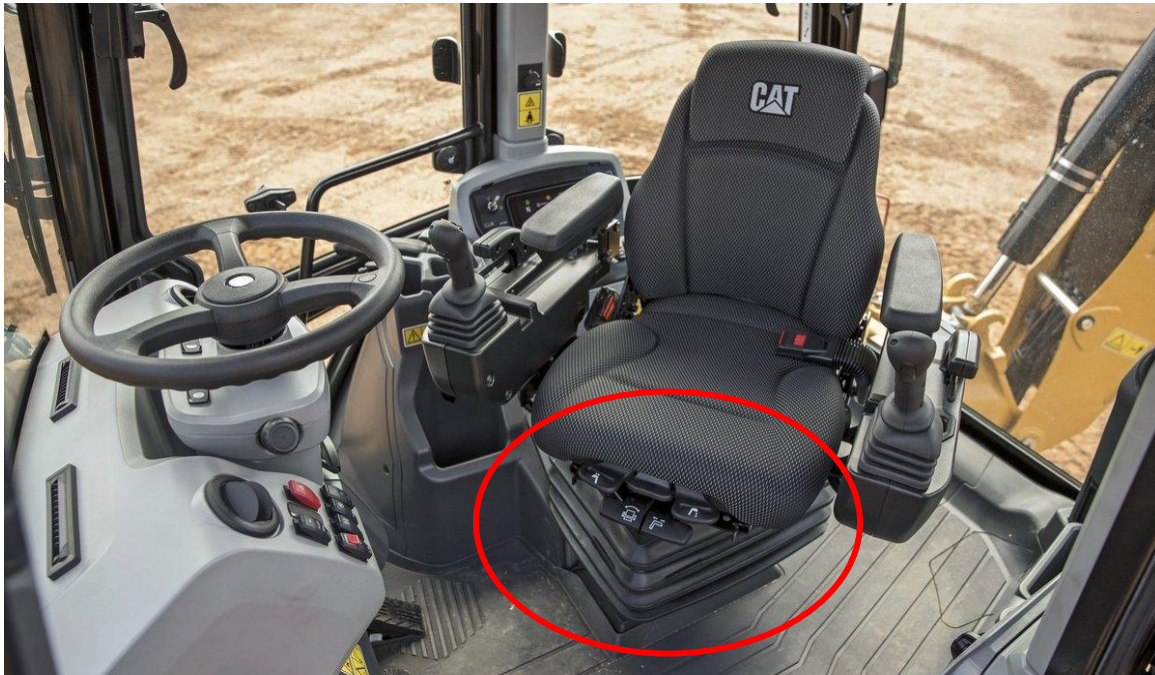
Figure A

- The operator attempted to adjust the seat while the equipment was in motion.
- The loader that the operator was using was missing the protective "boot" that houses the internal components of the adjustable seat.

- Operators of all vehicles/equipment that is equipped with an air ride seat shall verify that the protective boot is in place and intact around all of the seats adjustable components (as seen in Figure A) if this part is damaged or missing please notify the Service Center so they can get it replaced.
